**Expert Report of
Lawrence E. Eiselstein, Ph.D., P.E.**

**California Sportfishing Protection
Alliance (Plaintiff)**

**Pacific Bell Telephone Company
(Defendant)**

**Case No.
2:21-CV-00073-MCE-JDP**

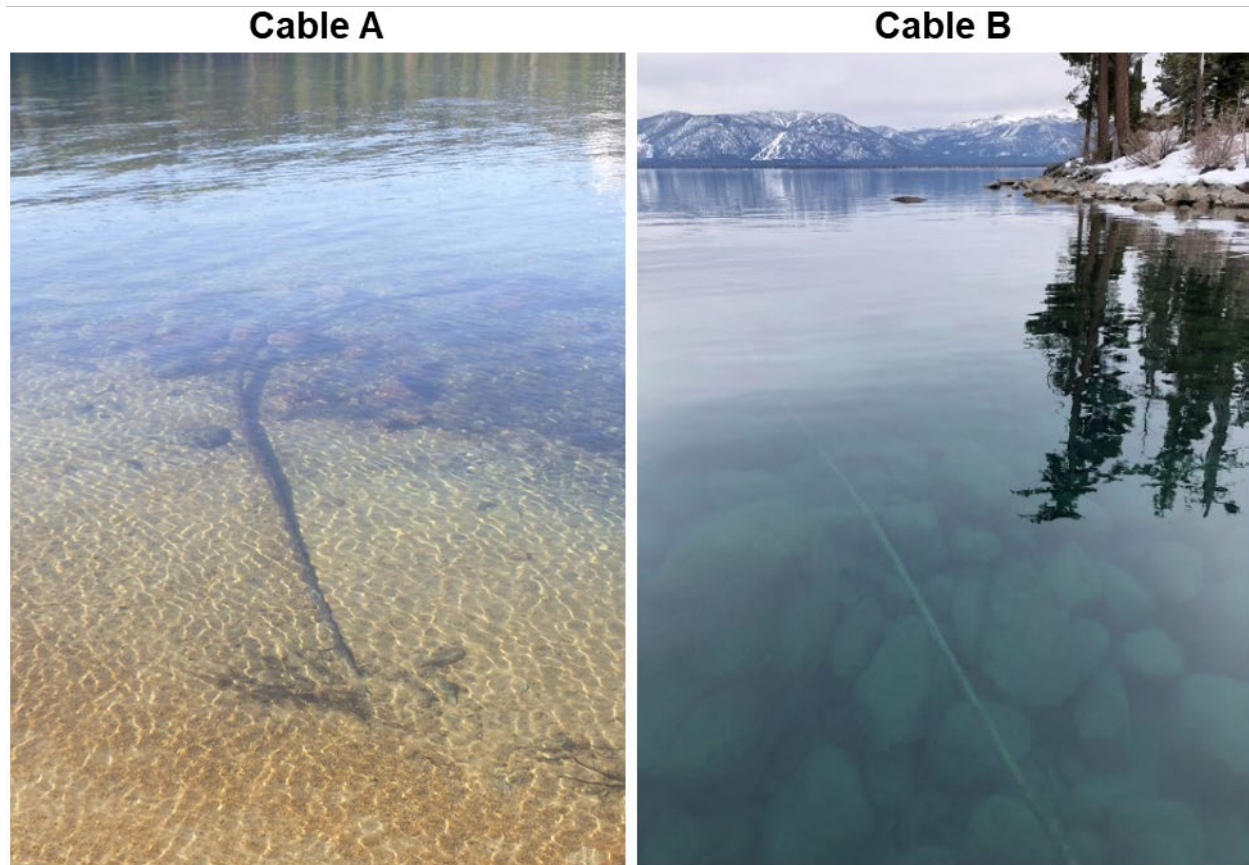
Figure 2. Photographs showing submerged Cables A²² (Ramboll US Consulting, Inc., photograph) and B²³ (Haley & Aldrich photograph) in Lake Tahoe.

I am aware of two surveys that evaluated the conditions of the subject cables. The first was a spot survey conducted by Haley & Aldrich, which examined “underwater and unburied portions of Cable A and approximately 1,800 feet of Cable B during the survey.”⁴⁹ Haley & Aldrich concluded that “[t]he spot surveys revealed that out of 18 locations surveyed along the length of the cables, 16 locations appeared visually competent with the outer jute-bitumen layer intact,” and “[o]ur observation of the cables using an underwater drone and video revealed the telecommunication cables along the observed length are predominantly competent with their steel armoring and jute bitumen layer intact.”⁵⁰

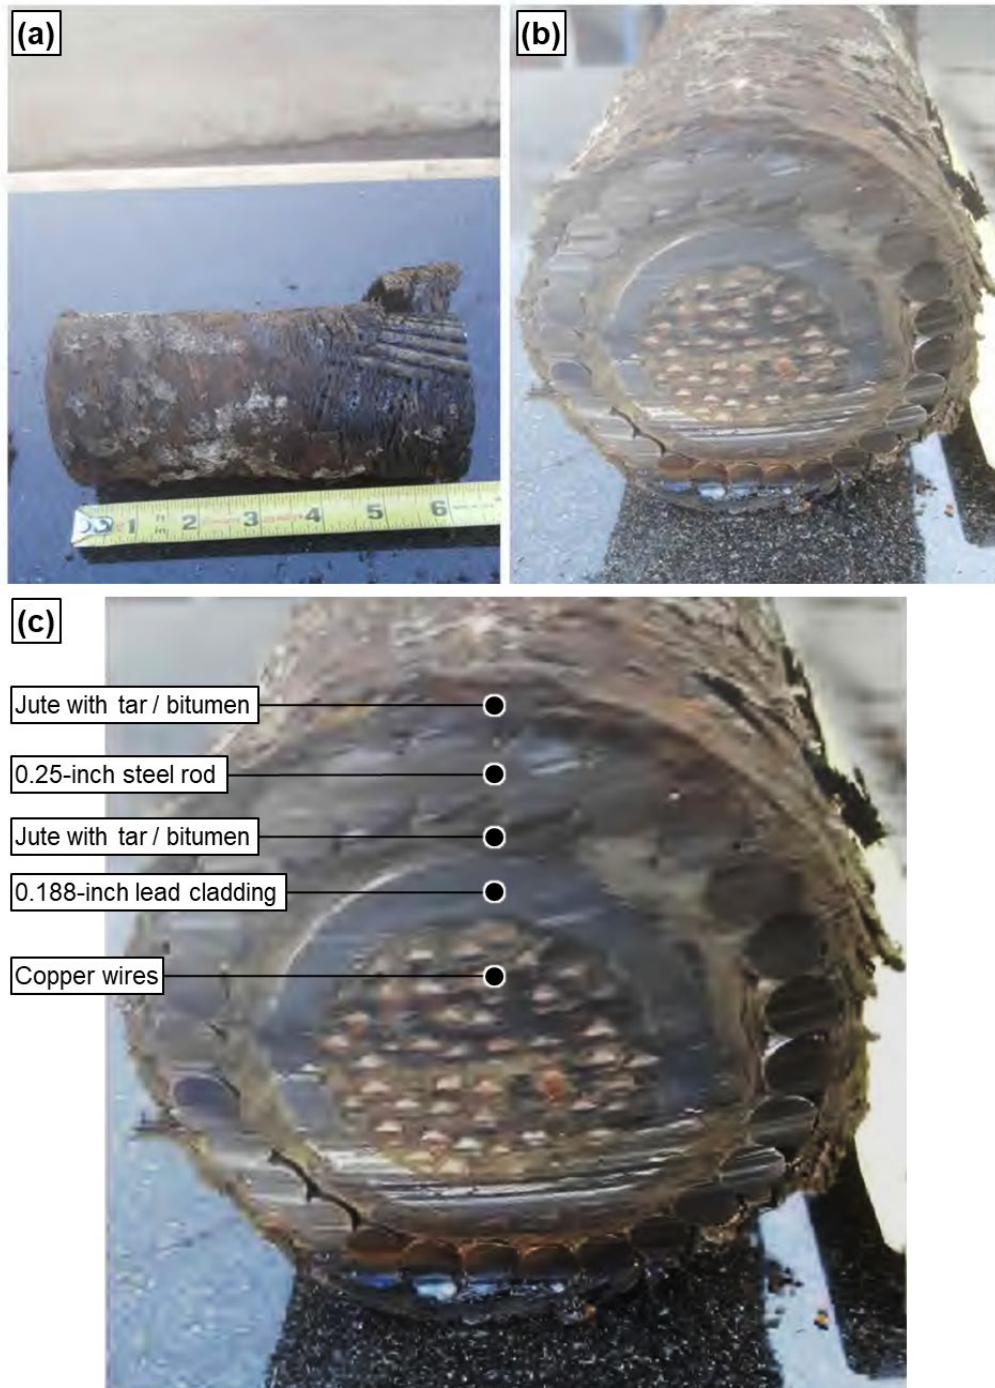
Figure 4. MTS photographs showing (a) a longitudinal view and (b) a transverse cross section through a segment of cable removed from Lake Tahoe,²⁵ and (c) the same transverse cross section as (b) but labelled by Exponent according to MTS descriptions of each layer in the cable.

All the layers noted above are between the lead cladding and the environment. In other words, the corrosion resistant lead cladding is (1) protected from mechanical damage by the steel rods and (2) protected from corrosion by the two separate layers of tar. The protective layers reduce interaction between environmental moisture and oxygen with the lead cladding, thereby reducing the potential for corrosion.

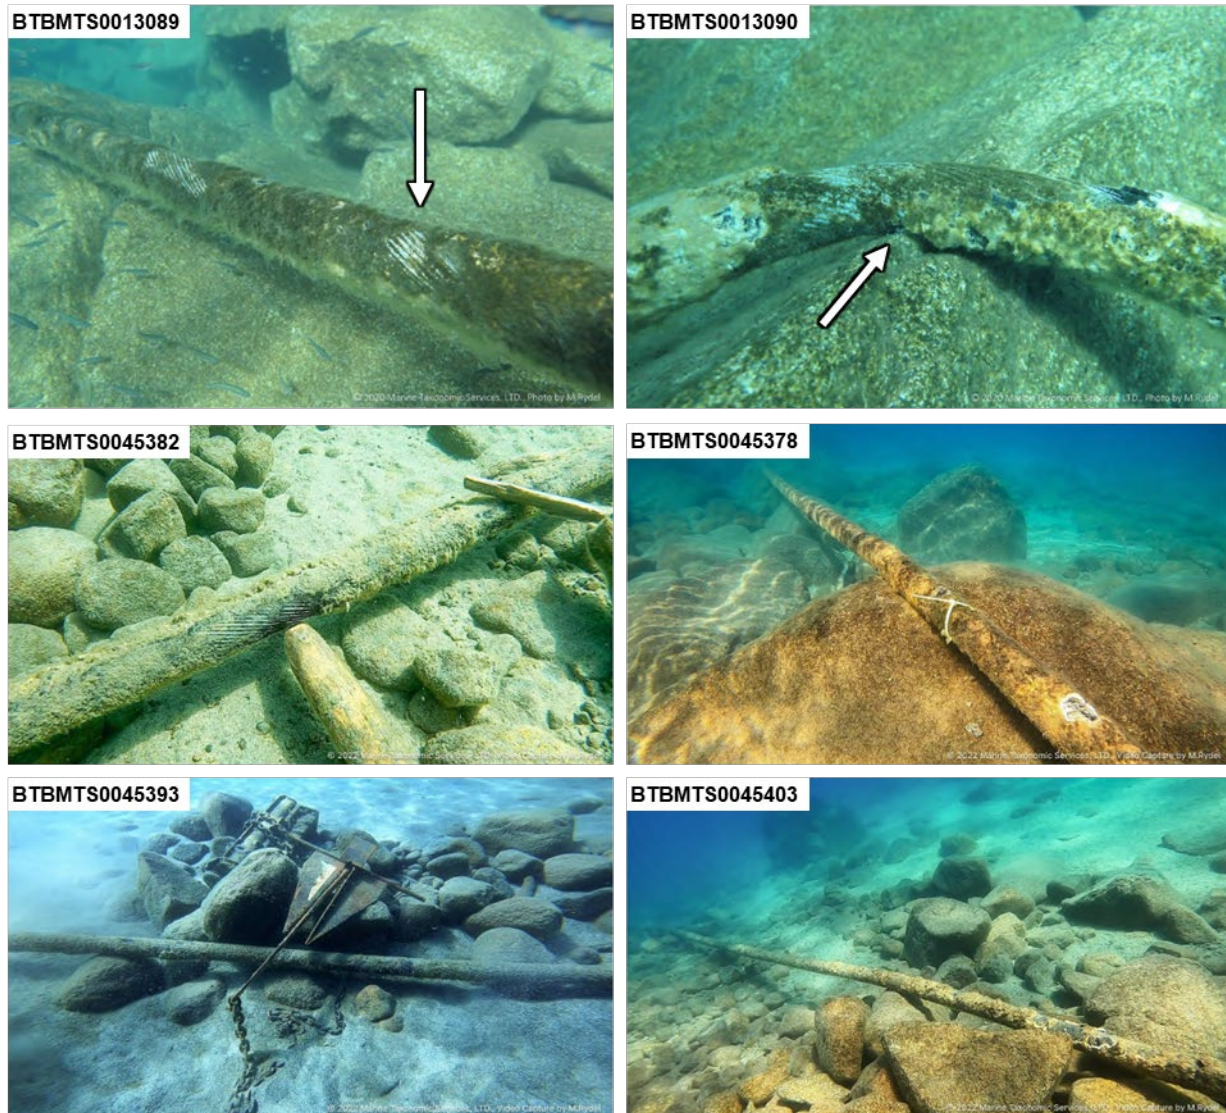
I reviewed comments for all 57 waypoints at which MTS divers noted that lead was visible. Based on my review, there were comments at 13 waypoints that indicated the lead was likely not visible and the remaining 44 waypoints had comments that were either consistent with lead allegedly being visible (according to the surveyors) or indeterminate.

In locations where the comments are consistent with damage to the cable that potentially exposed the lead cladding, the damage is described as localized (i.e., limited to discrete, isolated, and short sections of cable). For example:

- At Waypoint 14, the description states, “damage, possible lead exposed; sitting on large boulder.”⁵⁵
- At Waypoint 23, the description states, “[o]ver boulder, heavy wear and damage, with lead.”⁵⁶
- At Waypoint 94, the description states, “hung on rock, heavy damage, cable smashed, 4 ft long; lead visible.”⁵⁷

Figure 9. Representative examples of photographs produced by Plaintiff showing submerged lead-clad cables.⁵⁹ The arrow in the top left photograph was added by Exponent to illustrate a portion of the cable where the outer layer of tar-impregnated fiber disbonded and exposed the underlying steel rods. The arrow in the top right photograph was added by Exponent to illustrate a location where the cable appears to be damaged and interacting with a large rock. The outer layer of tar-impregnated fiber is absent, and the steel rods may be damaged, but it is unclear if the lead cladding is directly exposed to the water.
